# Manhole Inspection Summary

Manhole # S39I\_\_045MH

Insp Date: **11/26/08 11:36 AM**

**Location** Address: **800 fawn st**

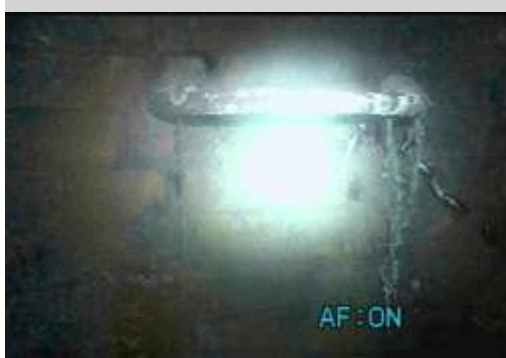
Defect 5

**Surcharge** ☒ **Evidence Of Surcharge** Depth: **7.5** (ft.) ☒ **Active Surcharge Present**

surcharge evd

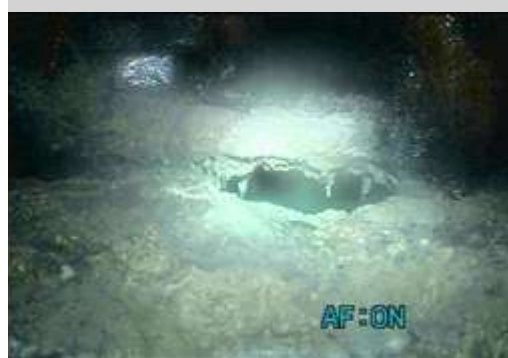
Defect 4

Condition: ☐ Sound ☐ Cracked ☐ Root Intrusion ☐ Deteriorated ☐ Leaks ☒ **Debris**

channel debris

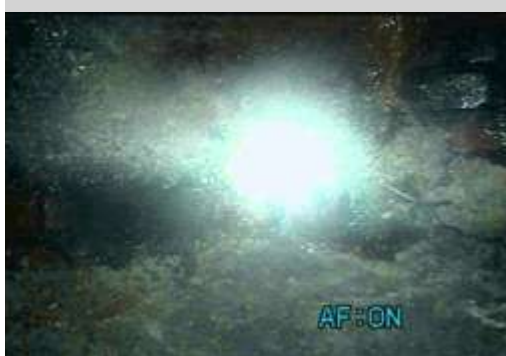
Defect 3

Condition: ☐ Sound ☐ Cracked ☐ Root Intrusion ☐ Deteriorated ☐ Leaks ☒ **Debris**

bench debris

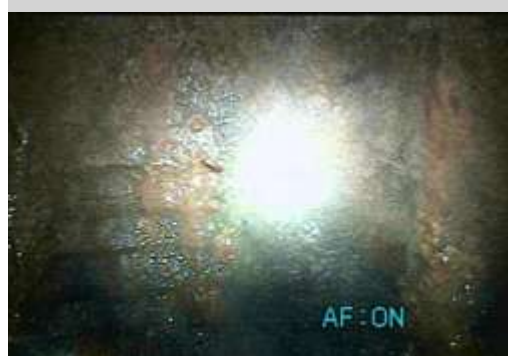
Defect 2

Infiltration: ☐ None ☐ Joint ☐ Cracks ☐ Mortar ☐ Roots ☒ **Wall**

barrel infiltration at wall

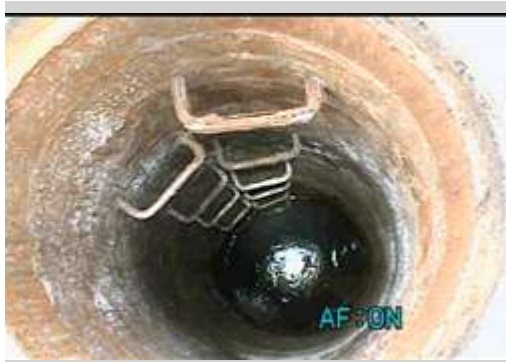
### Defect 1

**Steps** Count: **12** Missing: **0** ☒ **Corroded**

steps corroded

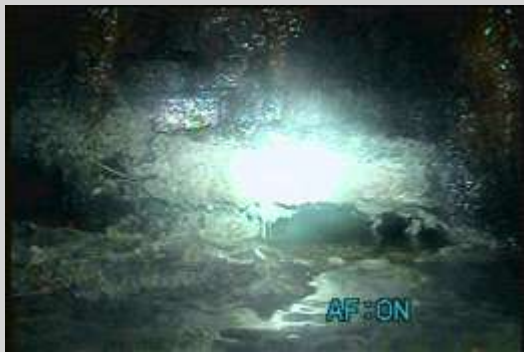
12 O'Clock Outflow

24 in. Circular Gravity Sewer  
Pipe Out @ 12 O'Clock

Invert Depth: **16.50** (ft.) Flow Characteristics: **Slow**

Infiltration: **None**

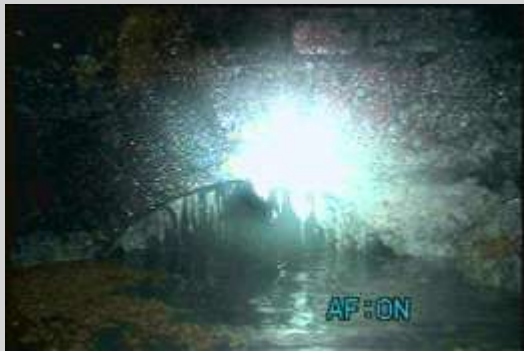
8 O'Clock Inflow

24 in. Circular Gravity Sewer  
Pipe In @ 8 O'Clock

Invert Depth: **16.41** (ft.) Flow Characteristics: **Slow**

Infiltration: **None**
